HAM PASS
ADDENDUM

Subject: GEOLOGIC REVIEW OF A PORTION OF LAND PROPOSED FOR TIMBER HARVEST

SUBJECT: Ham's Pass Timber Harvesting

Landslide Map Ham Pass area

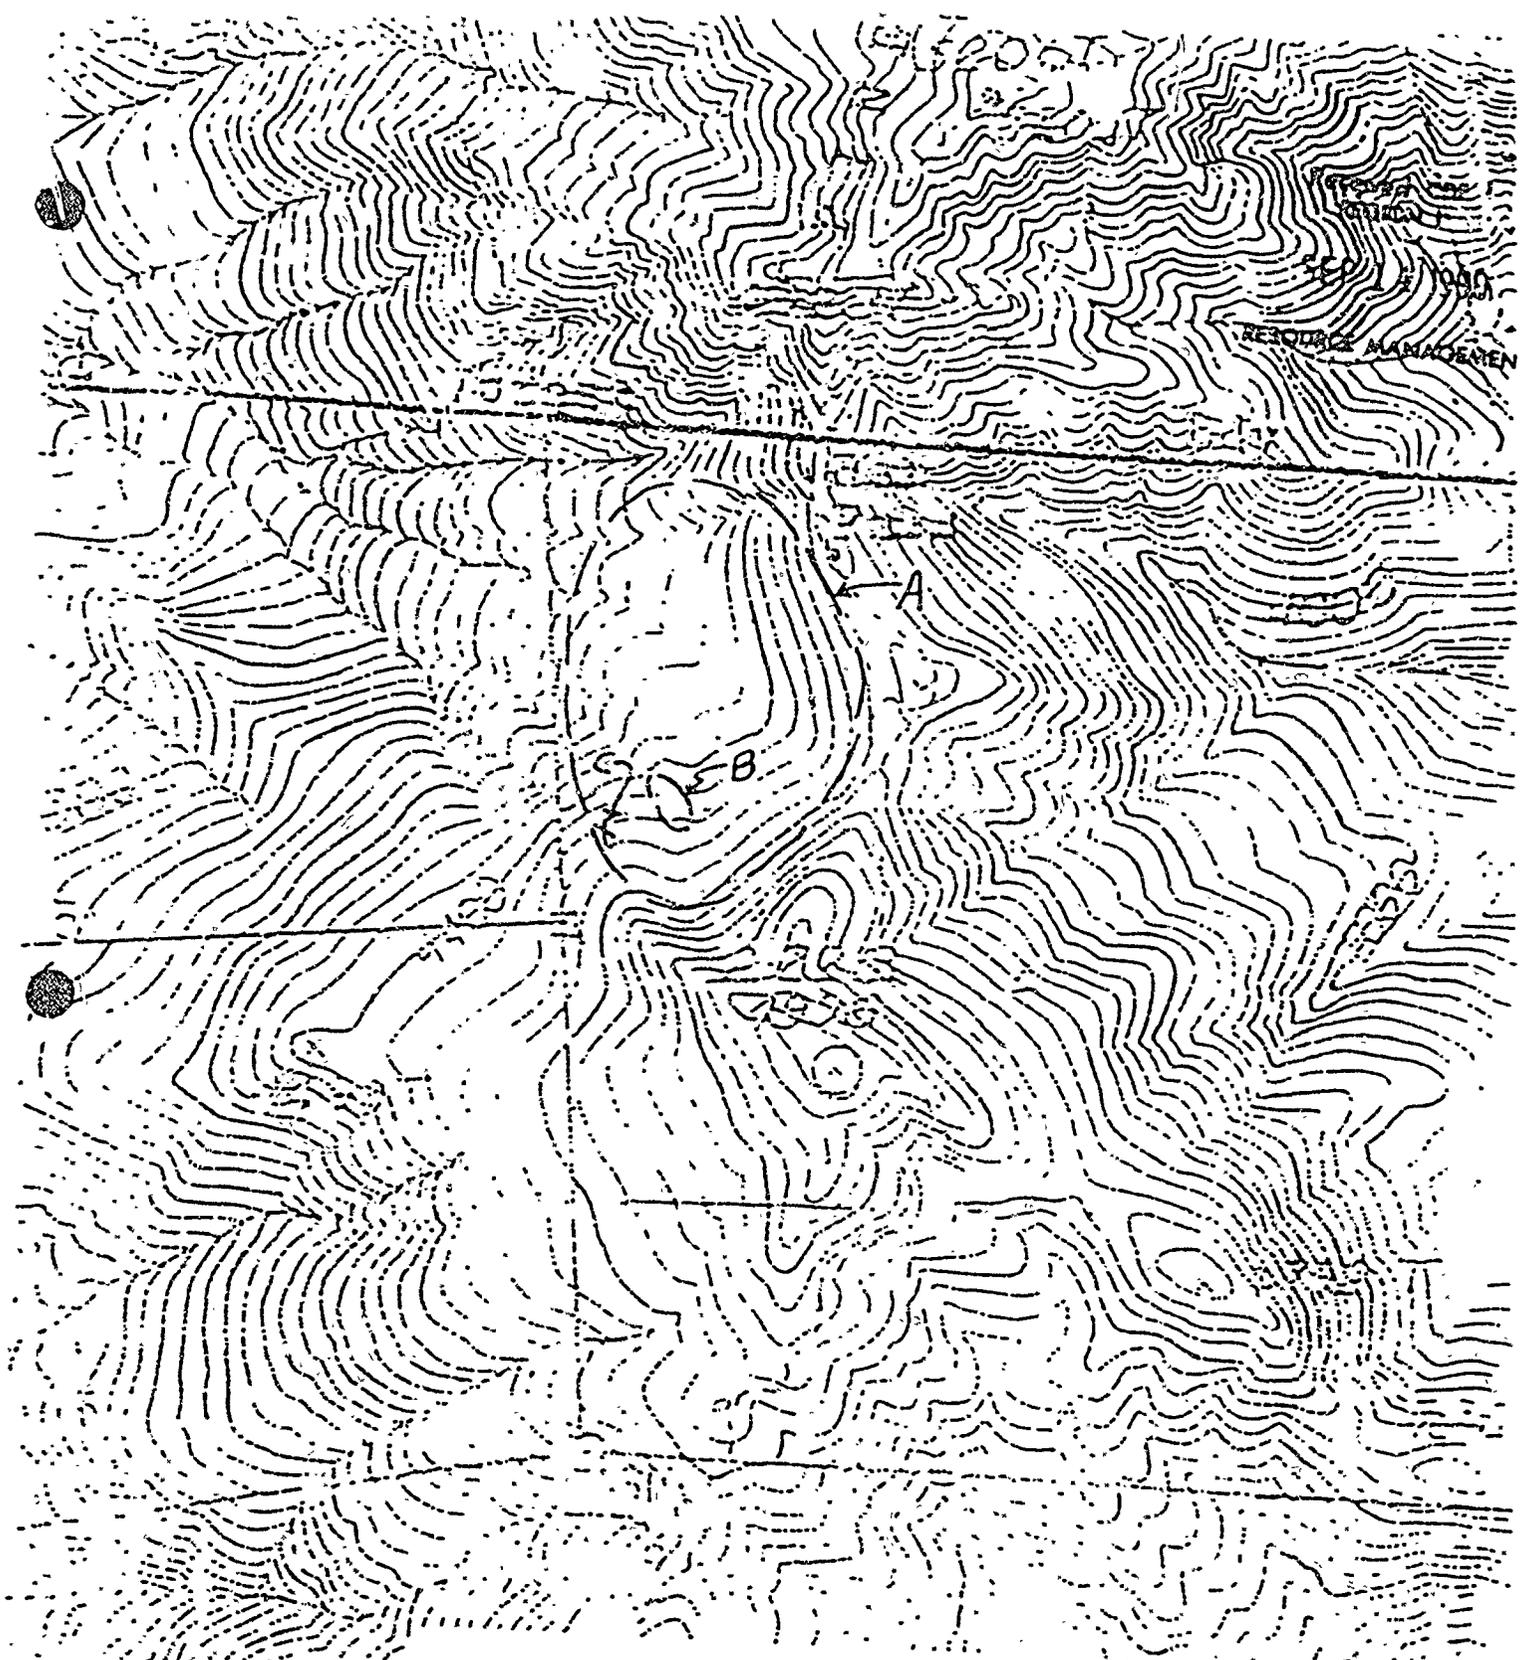
Map to Accompany Geologic Map
Proposed Timber Harvest, U. S. Forest
2/17/82

Landslides: There are three landslides, each of different age, which were observed.

- A. This is an ancient rotational slide/slump about 40 acres in size. At least two distinct episodes of movement are evident. The first, which may have been pre-Holocene, resulted in a large, thick, bench-like deposit of loose landslide debris which was subsequently deeply dissected by erosion. Efficient, V-shaped draws evolved which drained through the landslide area. A later episode of movement disrupted and terminated most of these draws by rotational movement and slumping. This last episode was clearly Holocene in age, as most of the draws are still disrupted or terminated. There are many deep, closed depressions, sag ponds, or draws ending in flats, where little or no surficial drainage occurs. Subsequent to the last episode of movement, a mature stand of timber containing Douglas-fir, sugar pine, and Incense Cedar has grown without any apparent signs of disturbance.

- B. This smaller landslide/slump of 1-2 acres in size is within the larger slide "A." It has occurred subsequent to the softwood timber stand and has resulted in a grove of nearly all oak re-establishing the ground. There are no recent signs of ground movement.

- C. This is a small (less than an acre) landslide/slump which occurred this winter (1982-83). At least three tilted or fallen fir trees were observed. There are fissures, scarps, and broken ground.

Landslides A and B:

Roads and skid trails should be constructed with as little cut and fill as possible. Skid trails particularly should be laid-out where little or no blademwork is necessary. Runoff should drain efficiently from all roads and skid trails by out-sloping, waterbars, and rolling dips. Inside ditches, inslopes and berms should be avoided on roads.

Landings should be built with as little excavation as possible - particularly cutting. Closed depressions may be filled if needed. Landings should be drained efficiently on completion.

Runoff from roads, trails and landings should not be directed into areas which do not drain, such as sag ponds or other closed depressions.

Furthermore, the stability of this area can be generally improved if sag ponds, closed depressions and flats are drained. A small bulldozer or backhoe could cut channels after the operation.

Landslide C:

Down and leaning timber can be removed from this area without further excavation.

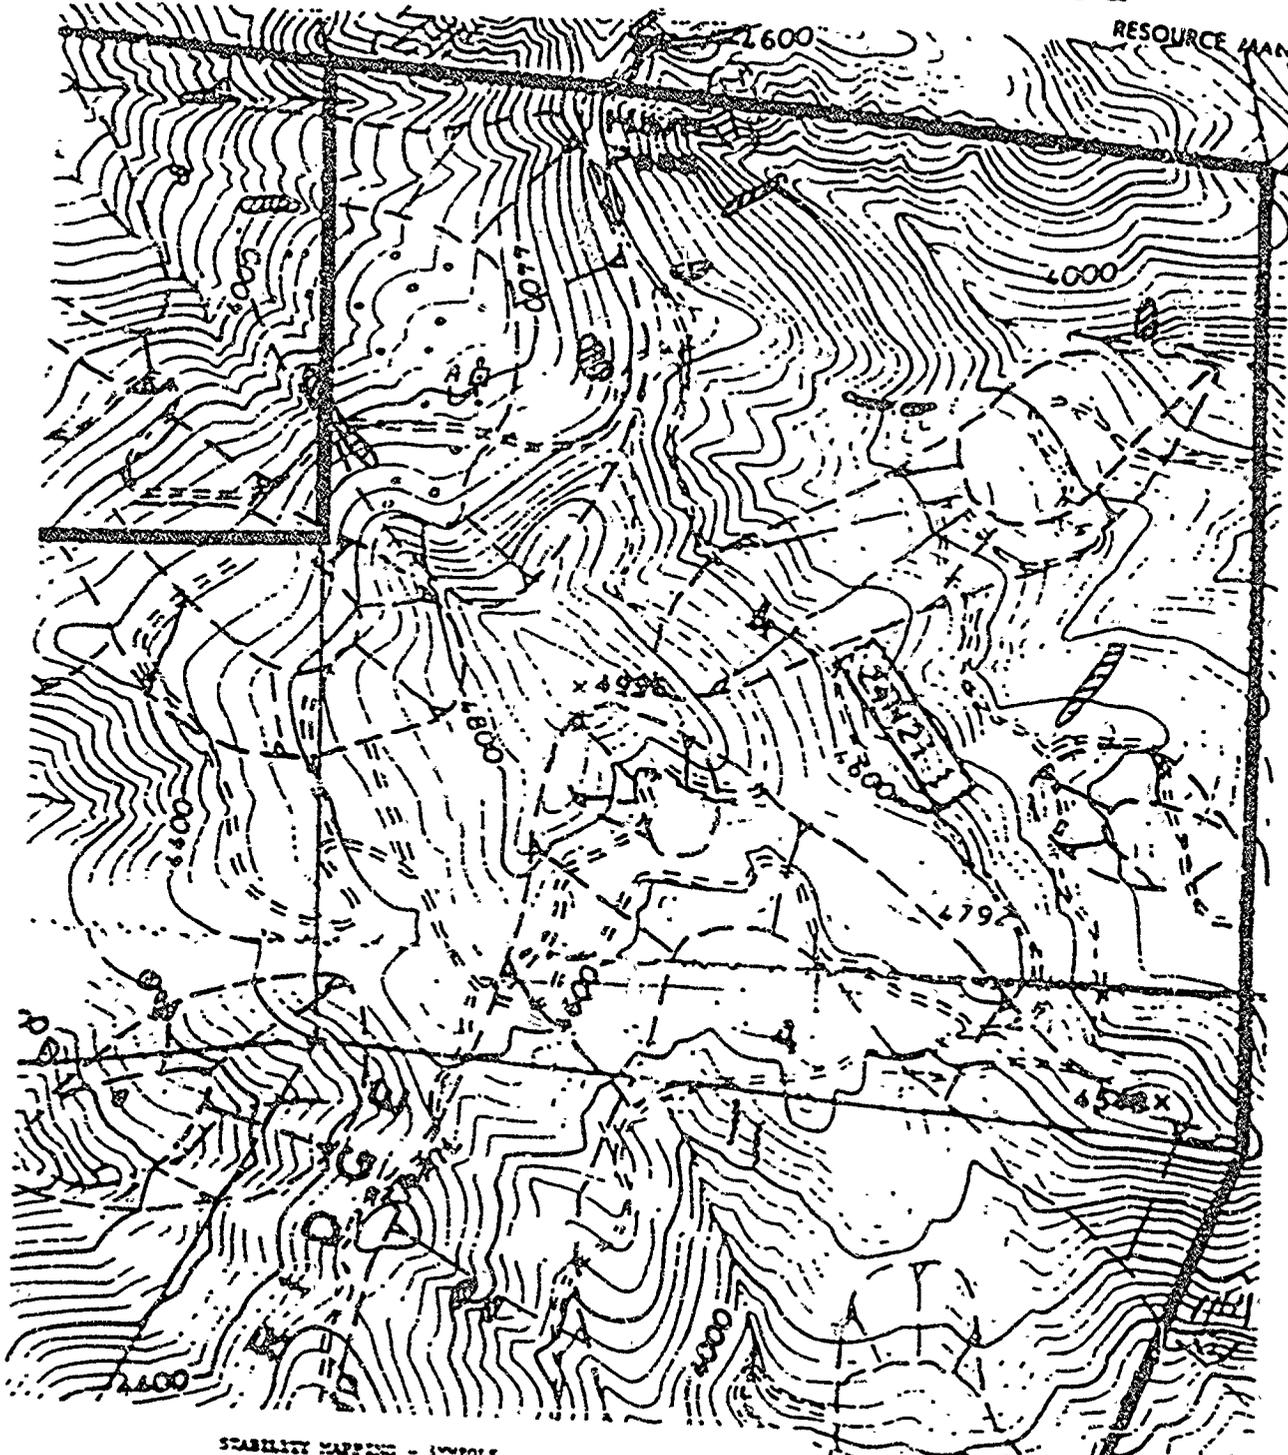
Numerous dormant landslides were mapped (see enclosed map) in both the unlogged as well as the previously logged area in addition to active landslides in both of the areas. The 1984 aerial photographs showed several active landslides not visible on earlier photographs. However, these may have been observed partly because of the larger, 1:12,000 scale photography of the 1984 photographs. These landslides did not appear to be related to prior logging activity although some may have been due to road construction.

One noticeable area of instability which is of great importance to timber management is the area along the western edge of Section 4. The road there crosses a large slide that extends both uphill and downhill from the road at approximately 4400 feet elevation. This slide, approximately 100 feet wide trends SE-NW 145-325 degrees and extends outside the harvest boundary downhill and over 1000 feet uphill. North of this road the ground is hummocky with numerous closed depressions which store water in ponds during wet periods and recharge the groundwater. Large deep gullies occur within the area mapped from aerial photos as multiple nested landslides. Some of these gullies developed from a swale over a short distance and may be the result of stream flows over disrupted, easily erodible landslide material.

North of the spur road in the area proposed to be harvested a large boulder strewn stream channel occurs at the area marked "B". The origin of the large boulders was not determined but could be the result of faulting or an unstable area uphill from the site.

A proposed logging access road departs from the spur road at about 4440 feet elevation. About the marked location (A) the road will cut into a slight scarp. Any cutting into the hillside at this point will probably initiate renewed mass wasting. The road should either be filled at this point or the road should be relocated below this critical point.

The area noted as an active landslide in the SW1/4 NW1/4, Section 4, T.23 N. R.11 W., should not be harvested for a hundred feet on either side of the center line of the landslide. This width of non-harvesting will give root support to the margin of the slide as well as assisting in reducing ground water table by transpiration.

The timber has already been marked within the area and several trees that have been marked are providing bank support and stability in an easily erodible area. A hydrologist or geologist should be allowed to paint over the marked trees to preserve stability and maintain erosion at an acceptable level.

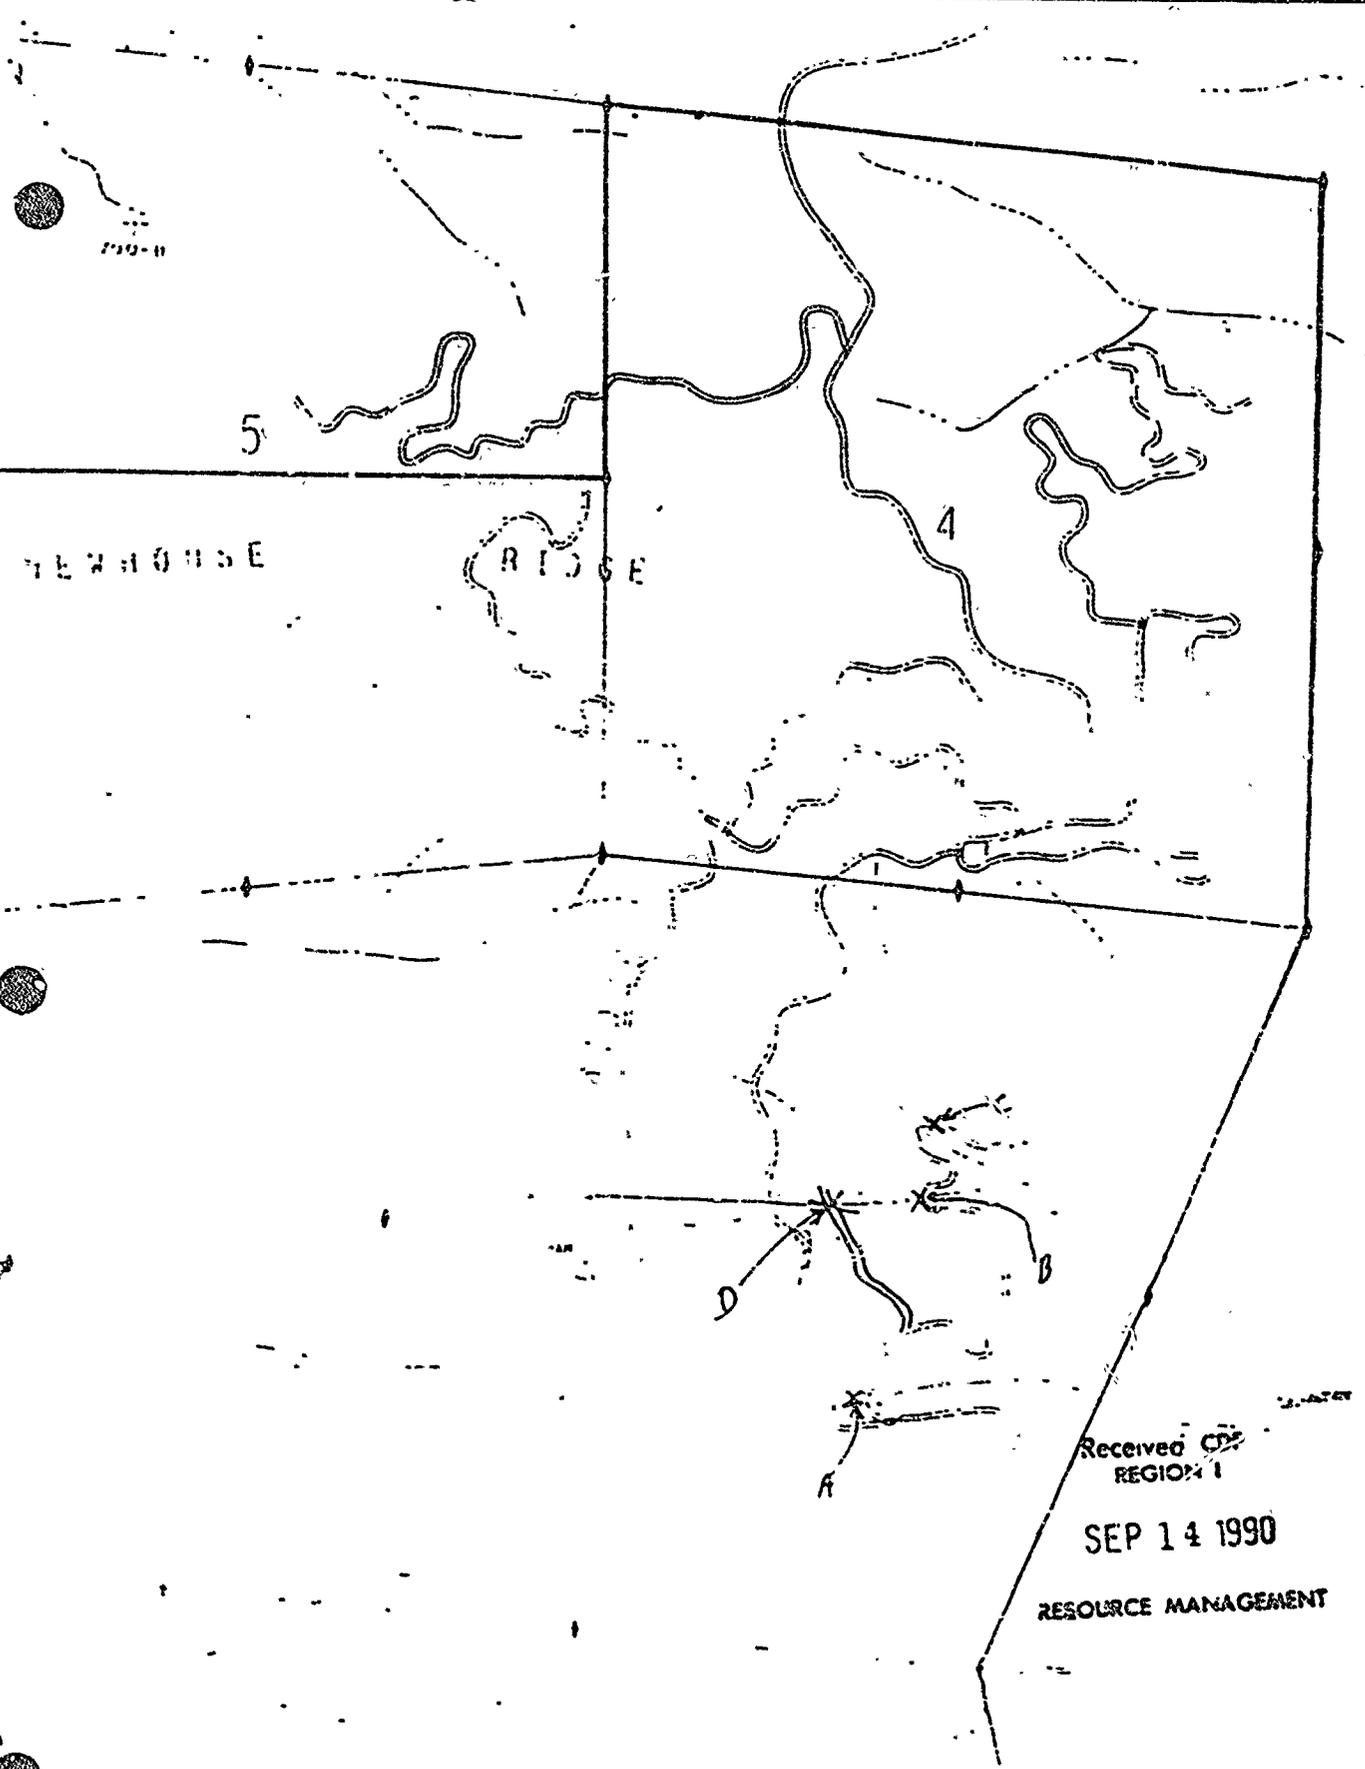
I also talked to him about the stream crossings in Section 9. He concurred with the Humbolt crossing above the water hole, (Marked A on attached Map). He said to put plastic over the logs before covering them with dirt. On the second stream crossing, (marked B), he had no problem with a backhoe digging out in front of the existing culvert, if it meets 50 years flood requirements, to redirect the water back into said culvert and dropping the road bed in order to cover the culvert. On the 3rd crossing, (Marked C), he has no problem with either a Humbolt Crossing or moving the existing culvert in the stream channel and lowering the road. The 4th crossing, marked D, he had no problem with a Humbolt crossing with plastic covering the logs before the application of soil.

I asked him his opinion on the need to preserve the over mature timber in the SLPZ up and down stream from the crossing marked B. He said these trees made up only 5% of the canopy protecting the stream and he had no problem with their being harvested. He did ask that those trees obviously cull be left along with the snags.

47. Along the WLPZ at the stream crossing marked B the decadent overmature timber in the over story will be removed. DFG Biologist Wooster said this timber made up only 5 percent of the canopy protecting the stream and could be removed. (see attached memo)
