Report On A Marine Survey Conducted  
by Argo Diving Services in  
January and April 1982  
at Santa Catalina Island

Mooring Count Conducted by Argo Diving Services

January and April 1982

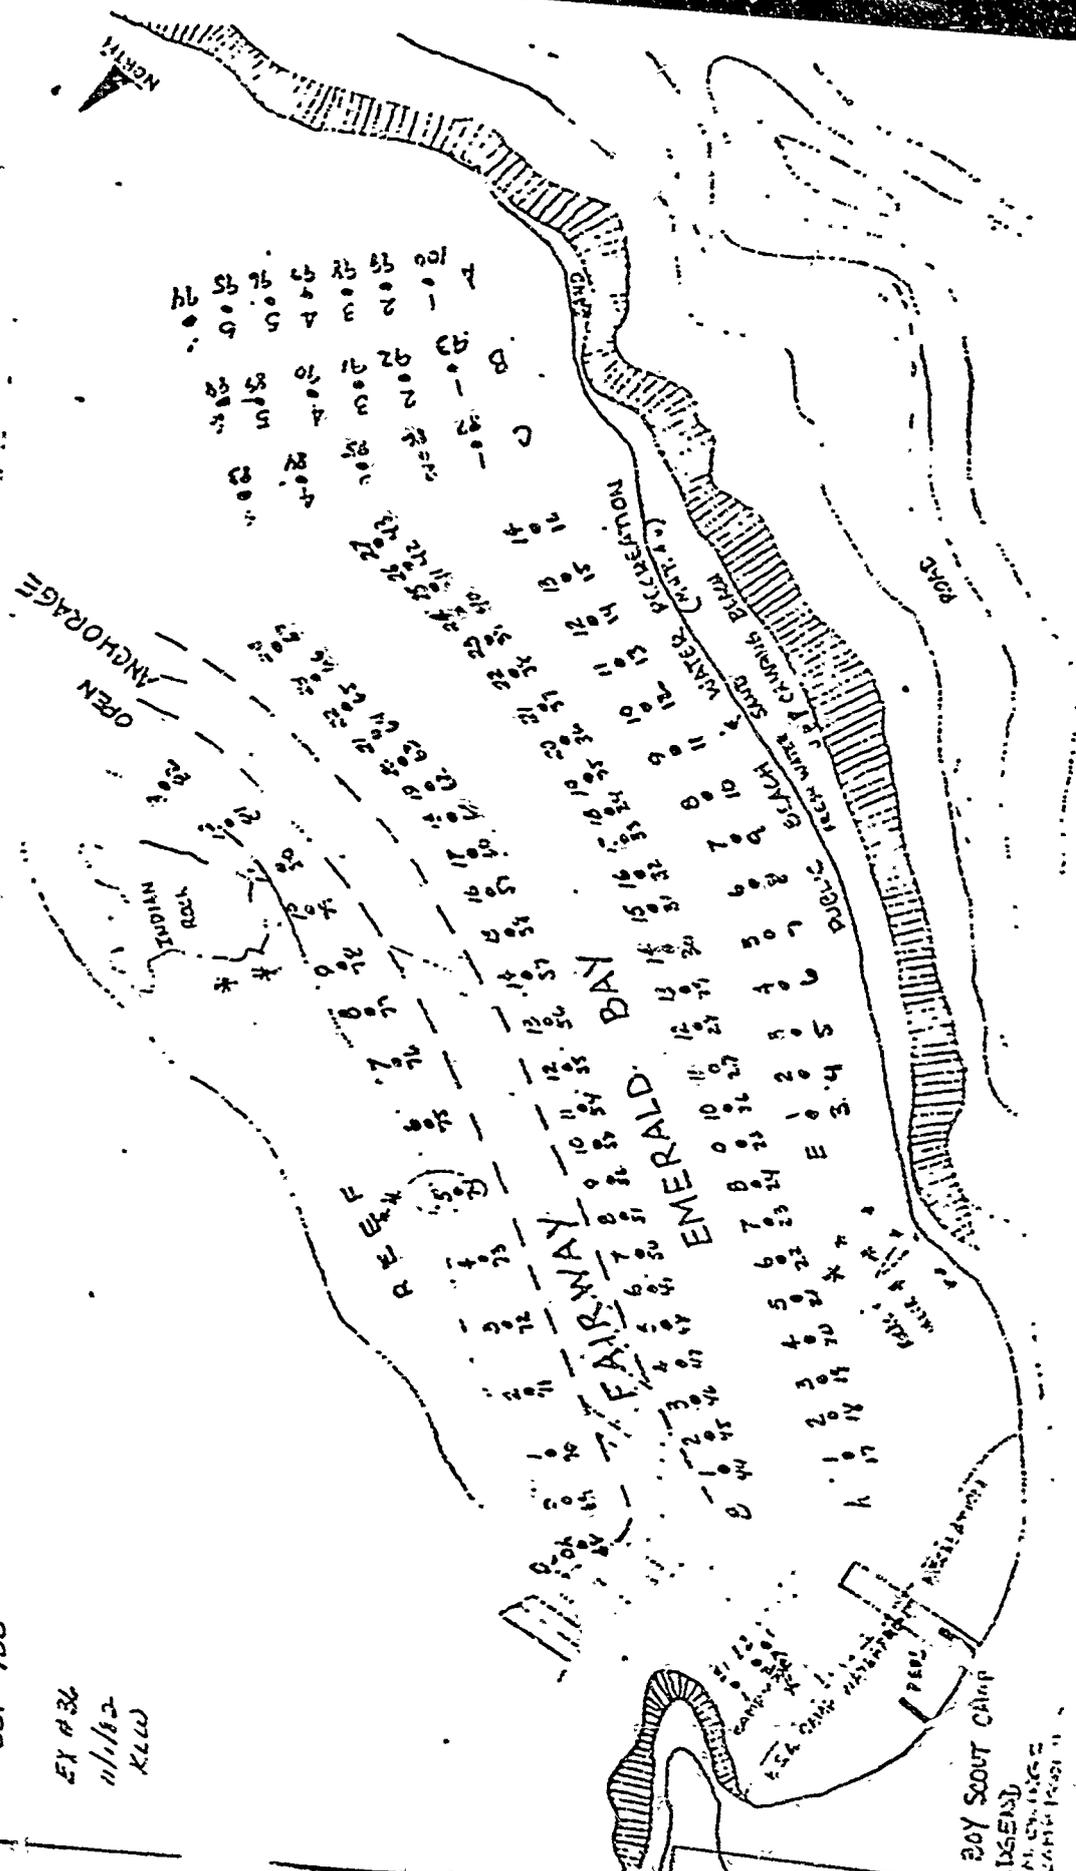
# MOORING INSTALLATION CHART HOWLAND LANDING

PREPARED BY CATALINA COVE & CAMP AGENCY  
MOORING SERV. DIV. PO BOX 156, SULLOW, CALIF.

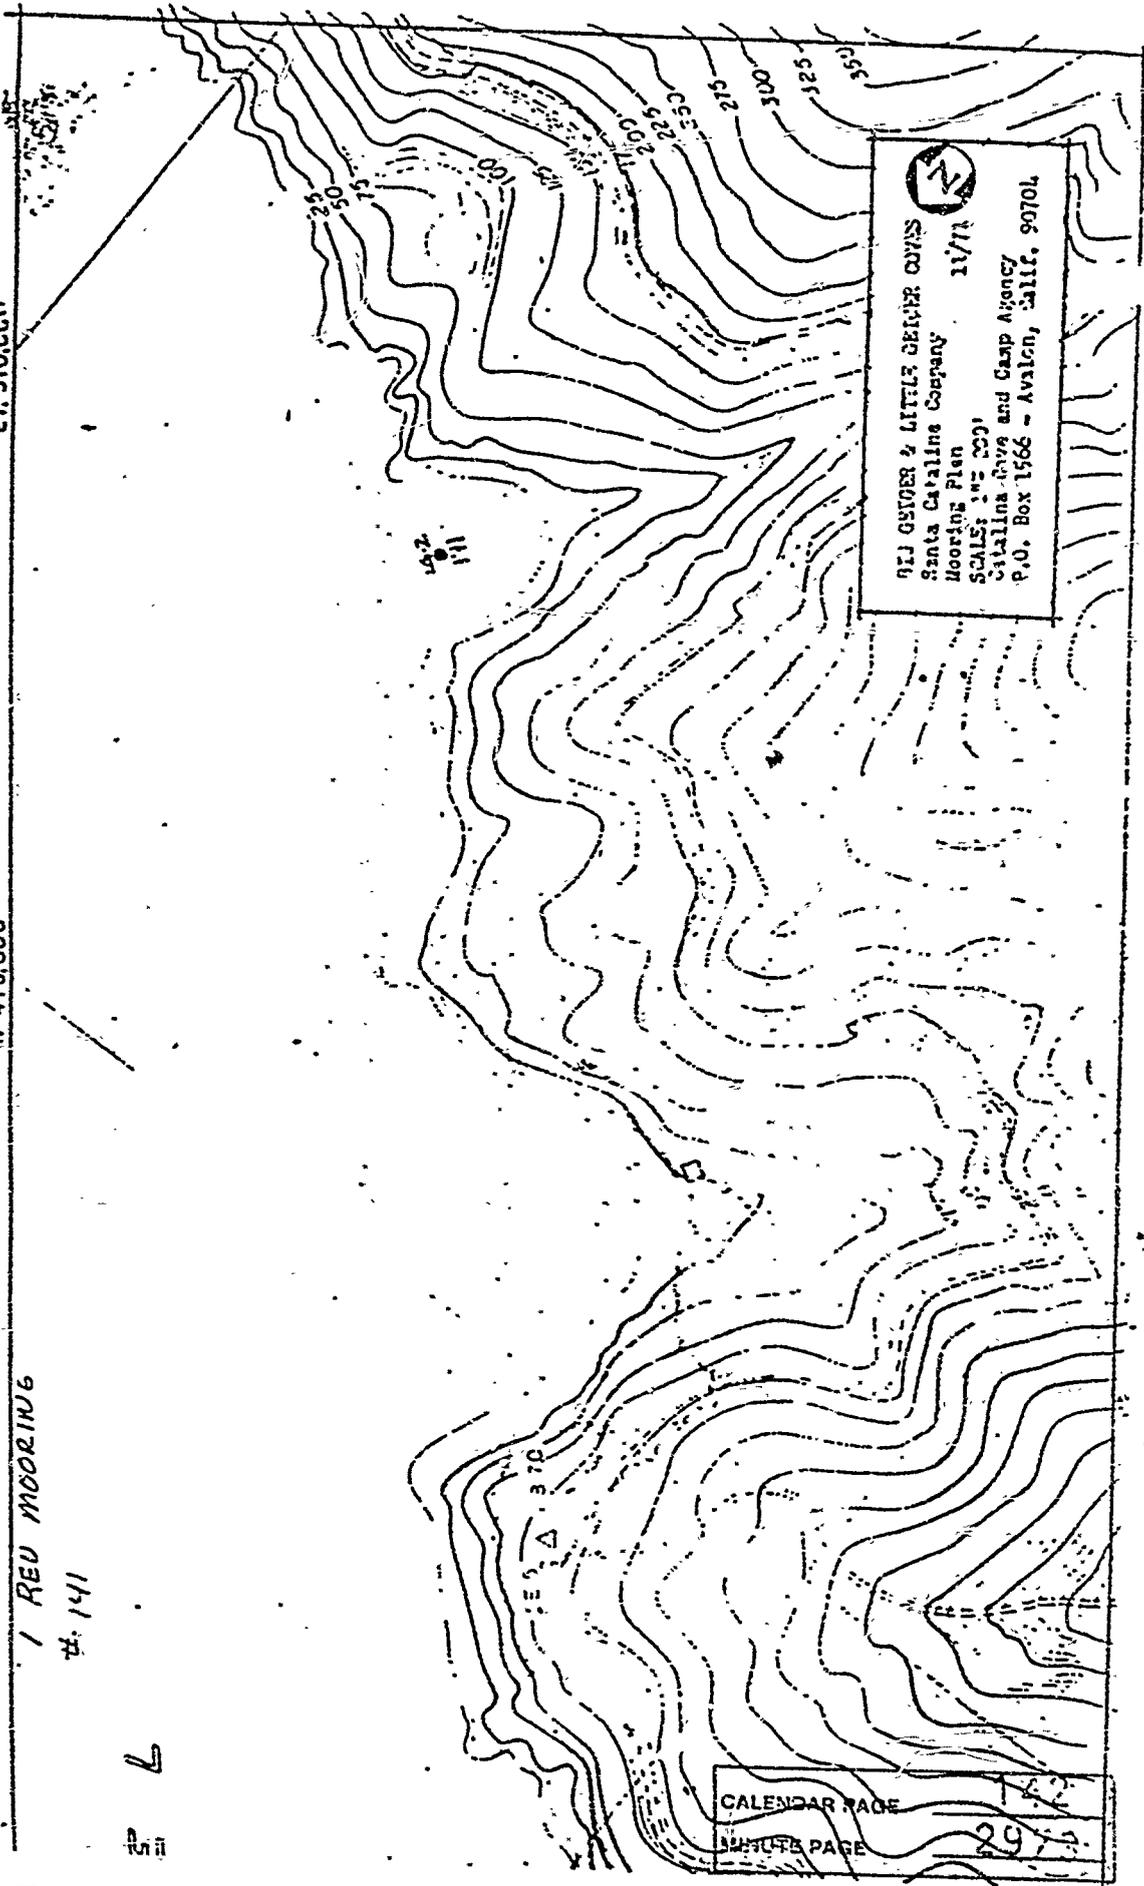
R. J. GUNTER & LITTLE BECKER COVINS  
 Santa Cataline Company  
 Mooring Plan  
 SCALE: 1" = 200'  
 Catalina Cove and Camp Agency  
 P.O. Box 1566 - Avalon, Calif. 90704

103 REV MOORINGS  
# 142 - 244

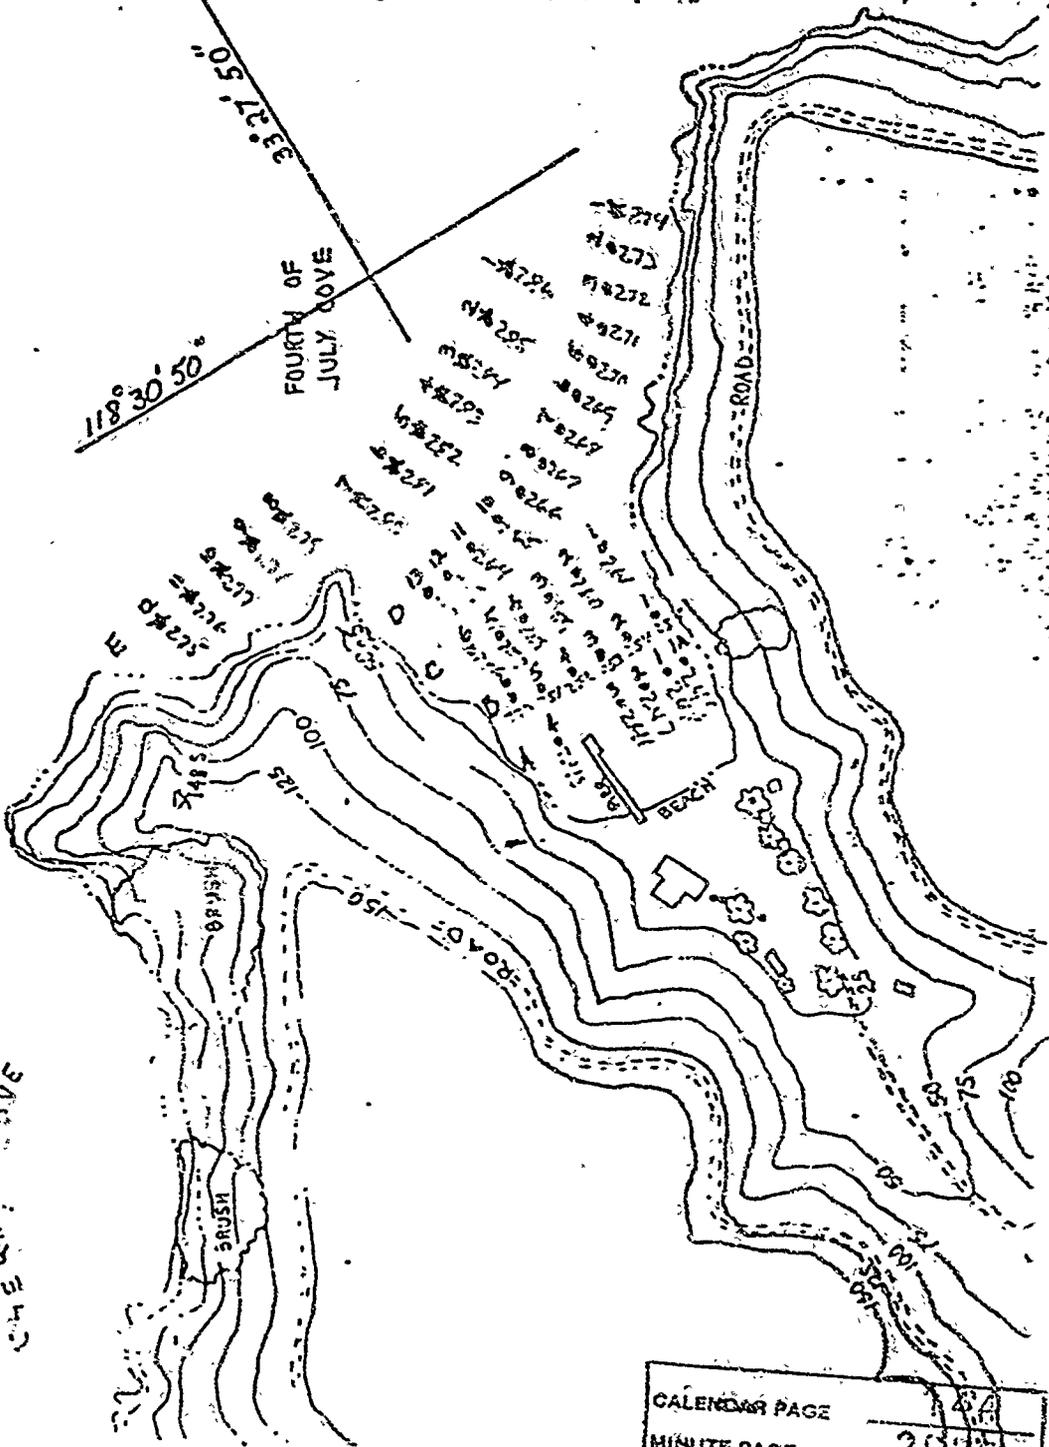
CHEWY COVE

#215 -286
