Figure 5
SURFACE RUNOFF

Appendix B
TERRESTRIAL BIOLOGY REPORT

VEGETATION SURVEY OF THE ABALONE FARM PROJECT SITE, CAYUCOS, CALIFORNIA

Report on the Cayucos Abalone Farm and Environs,
With Respect to the Marine Environment

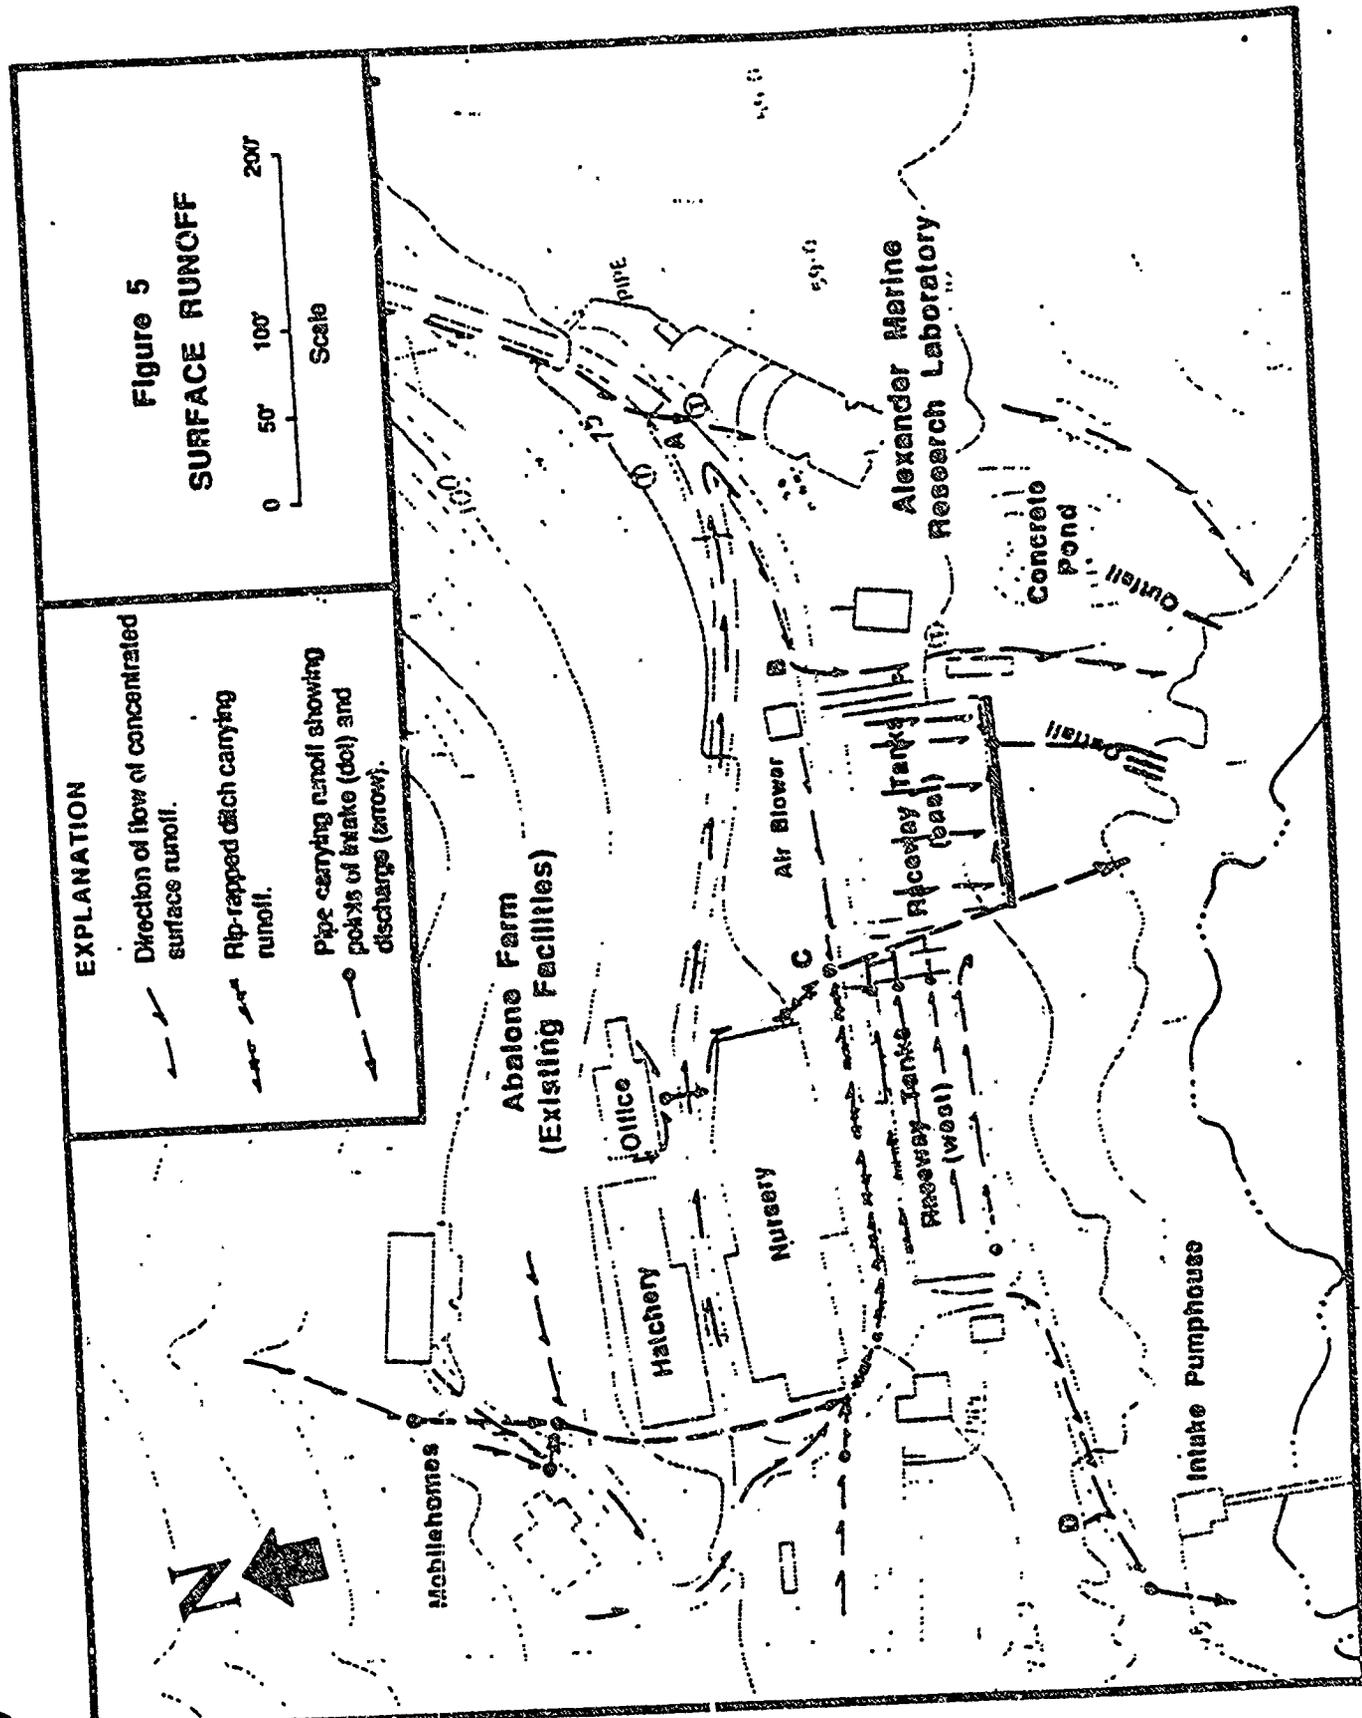
Direction of flow of concentrated surface runoff.

Rip-rapped ditch carrying runoff.

Pipe carrying runoff showing points of intake (dot) and discharge (arrow).

- Drainage control should be improved at Points A and B (Figure 5), north of the Alexander Marine Research Laboratory, so that concentrated runoff is conveyed westerly along the access road to the primary collection point C rather than crossing the road and flowing to the bluff along uncontrolled channels.

- Concentrated runoff from above the steep segment of this road (easterly of Point D

on Figure 5) should be intercepted and conveyed to the box inlet at the bottom of the road by a pipe buried in the roadway. (This improvement is intended to minimize runoff flowing down the steep segment of the road and consequent erosion and sedimentation at the box inlet.)
