HAM PASS
ADDENDUM

Subject: GEOLOGIC REVIEW OF A PORTION OF LAND PROPOSED FOR TIMBER HARVEST

SUBJECT: Ham's Pass Timber Harvesting

Landslide Map Ham Pass area

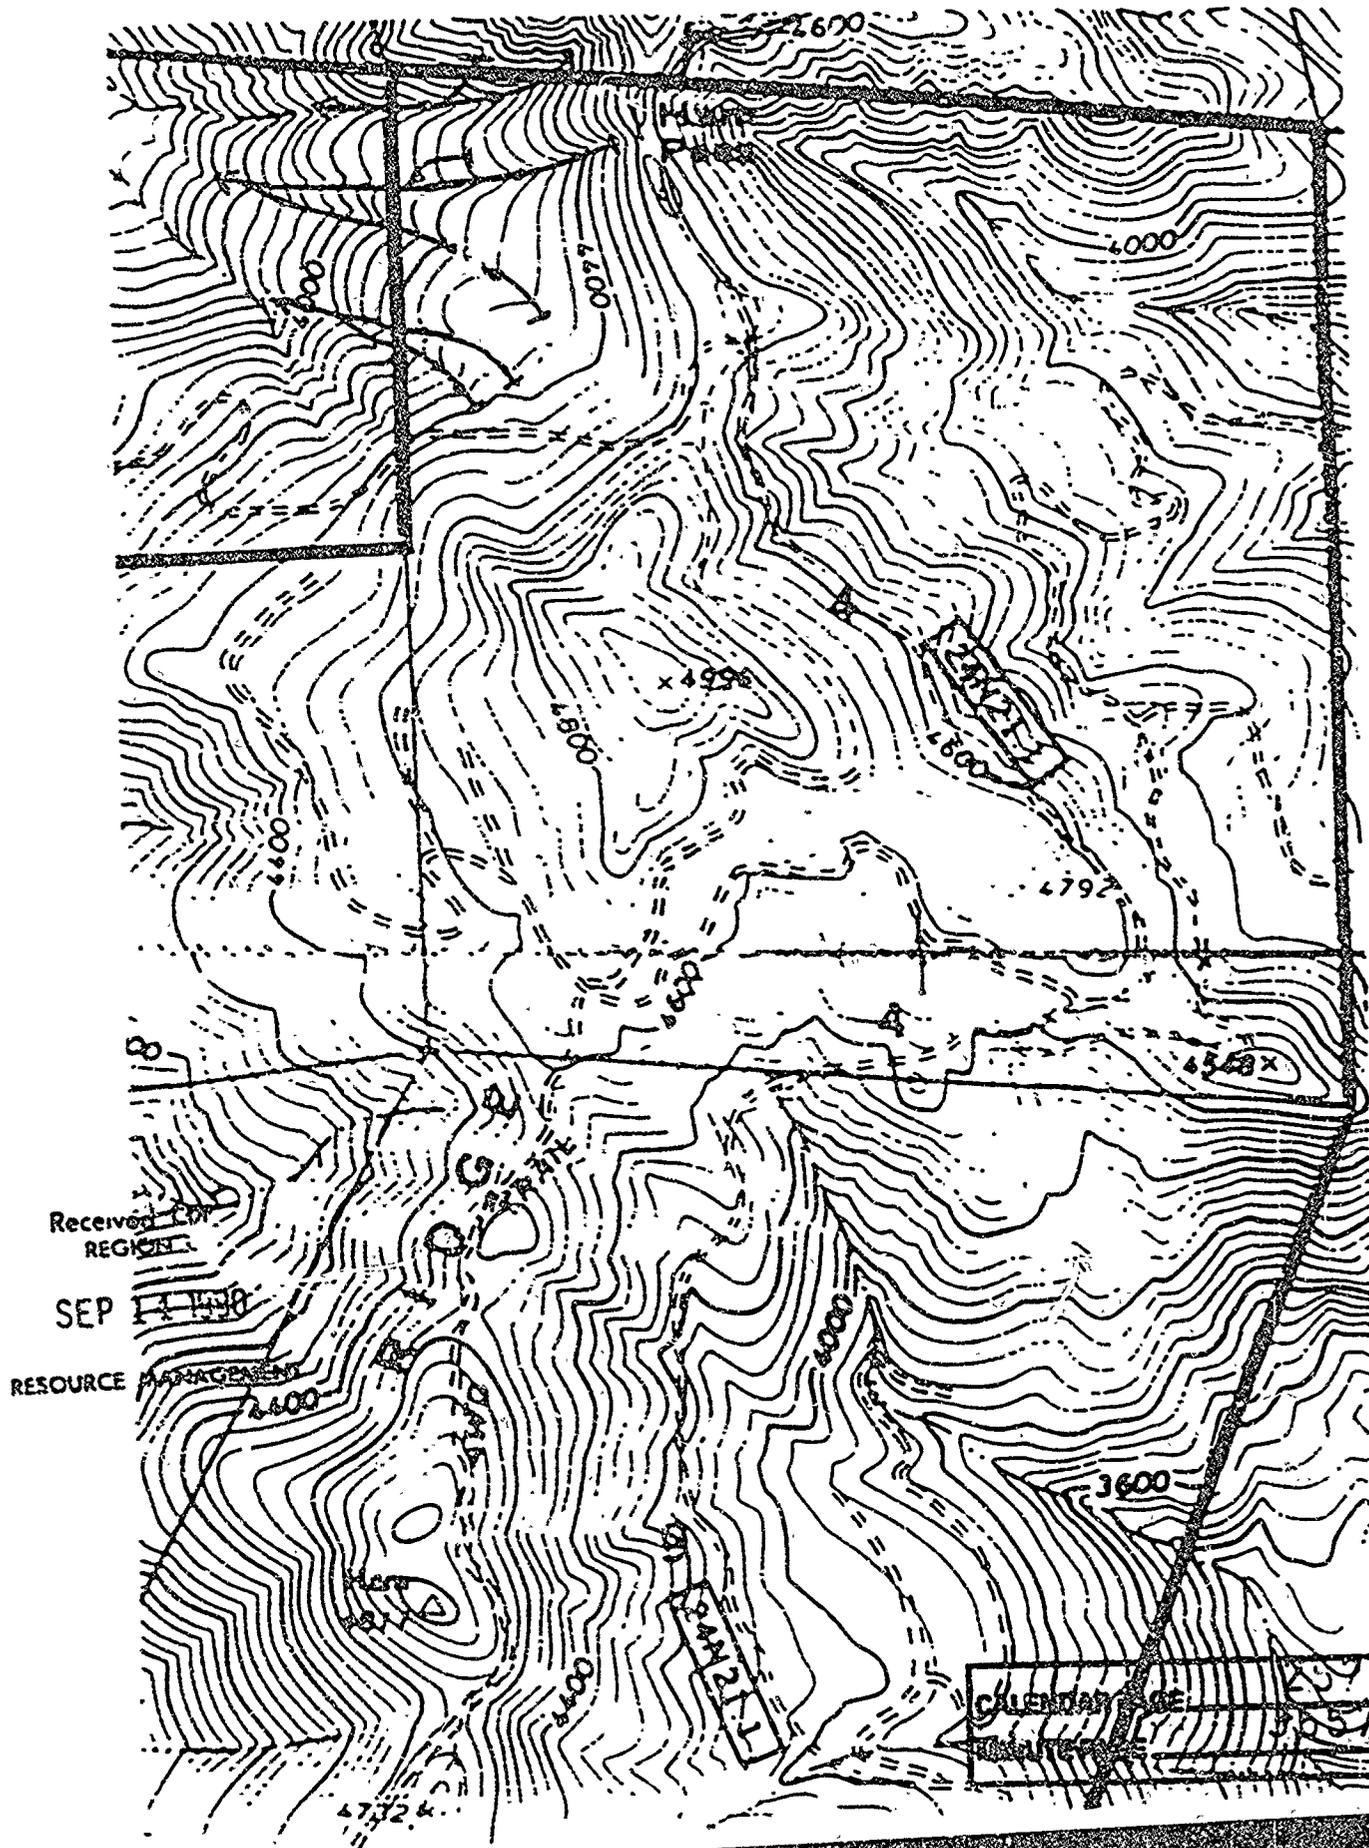
Numerous dormant landslides were mapped (see enclosed map) in both the unlogged as well as the previously logged area in addition to active landslides in both of the areas. The 1984 aerial photographs showed several active landslides not visible on earlier photographs. However, these may have been observed partly because of the larger, 1:12,000 scale photography of the 1984 photographs. These landslides did not appear to be related to prior logging activity although some may have been due to road construction.

The area noted as an active landslide in the SW1/4 NW1/4, Section 4, T.23 N. R.11 W., should not be harvested for a hundred feet on either side of the center line of the landslide. This width of non-harvesting will give root support to the margin of the slide as well as assisting in reducing ground water table by transpiration.
